Manhole Inspection Summary

Manhole # S41E__067MH

Insp Date: **11/24/08 11:12 AM**

Location Address: **4 n. central av**

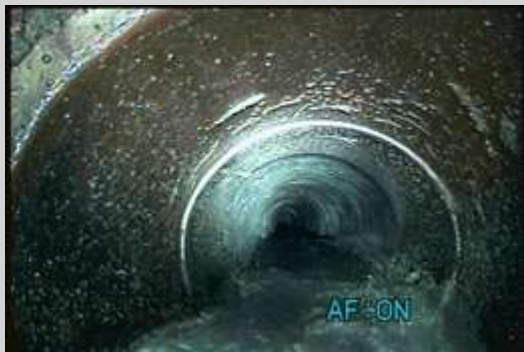
12 O'Clock Outflow

21 in. Circular Gravity Sewer
Pipe Out @ 12 O'Clock

Deposits: ☒ None ☐ Mud ☐ Sludge ☐ Debris ☐ Grease

Infiltration: **None** Pipe Seal Cond: **Unknown**

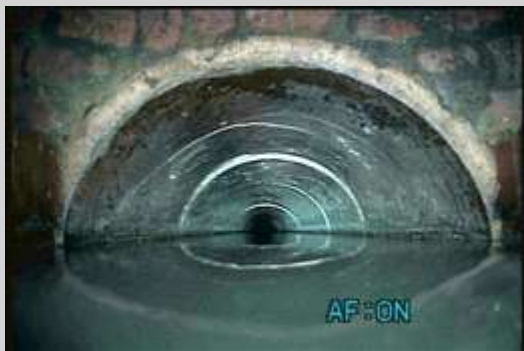
6 O'Clock Inflow

21 in. Circular Gravity Sewer
Pipe In @ 6 O'Clock

Infiltration: **None** Pipe Seal Cond: **Unknown**
